ULTRASONIC TESTING INSPECTION AND CORROSION ANALYSIS OF HULL AND MOORING CLUSTERS OF BATTLESHIP TEXAS (BB-35)

Ocean Technical Services, LLC.

Construction Contract No.: 101887: TPWD

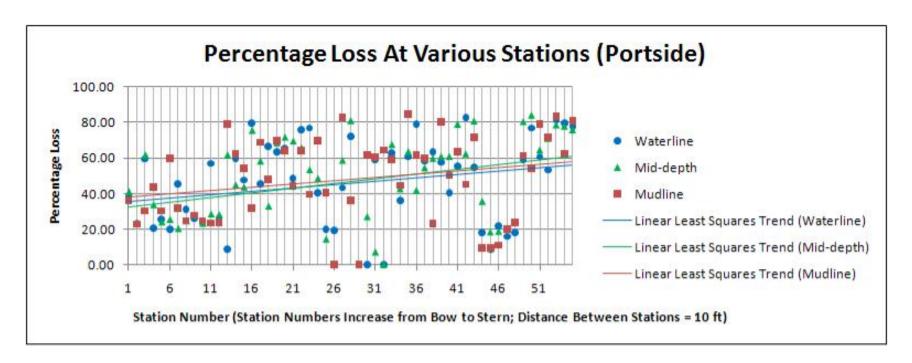
Figure 1 Percentage Loss of Hull Plating at Stations No. 1 Through Station No. 55 (PORT) (Linear Trend Lines for Measurements at Each Water Depth Are Also Shown)

APPENDIX B provides the measurements in tabular form with original plate thickness, current plate thickness measured, actual plate loss and percentage plate loss at the various depths and station locations, for both Port and Starboard sides. The percentage losses are shown graphically in Figure 1 and Figure 2 and indicate no obvious trend although a slight increase in percentage loss with increasing distance from the bow is seen in Figure 1. The maximum percentage losses are 84.57 % for Station 35 (Bottom measurement) for Portside, and 82.94 % for Station 15 (Waterline measurement) for Starboard side.

These measurements confirm that the vessel's shell plate structure (for both blister tanks and the hull) is failing and is in need of urgent repair through dry docking, or in this case, a dry berthing solution.

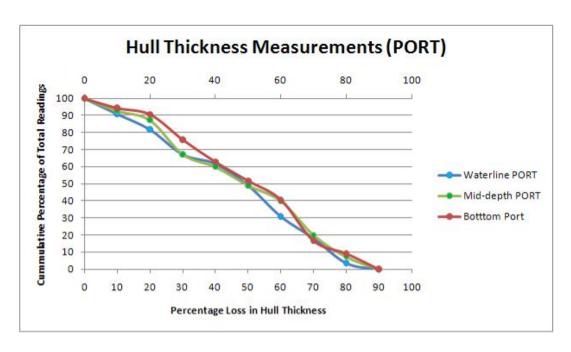
Figure 3 Exceedance Frequency Curve for Percentage Loss in Hull Thickness (PORT)

Figure 3 and Figure 4 show the "exceedance frequency" curves for the hull thickness percentage loss for Port and Starboard sides, respectively, where the percentage loss in hull thickness is plotted against the cumulative percentage of total number of readings taken during the inspection. Both figures indicate fairly similar patterns for all three measurement depths. For both Port and Starboard sides, approximately 50 % or more of the measurements indicate a percentage loss of 50 % for the hull thickness at all three measurement depths.

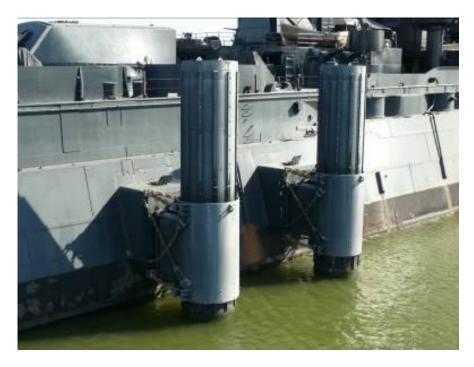
Figure 5 Aft Pair of Mooring Clusters (Starboard Side)

The vessel's mooring clusters (Figure 5 and Figure 6) appeared to be in fine repair and have many years of service life remaining. Inspection by the dive team revealed no significant structural

problems with the cells down to the mud line.

Interior inspection of the four boxes revealed the structures to be in excellent condition. Likewise, the underwater inspection of the four piles showed uniform UT readings from waterline down to the mudline. UT readings of each cluster were taken at three vertical elevations (Waterline, Mid-depth and Mudline) and four compass orientations (N, S, E, W) relative to the slip orientation and are shown in Table 1

The mooring cluster piles appear to be in excellent structural condition with above-water weldments appearing in good condition.

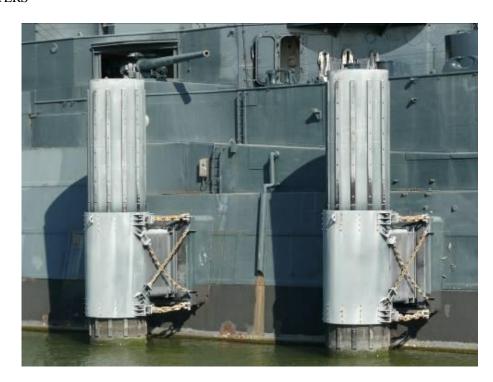
Figure 6 Forward Pair of Mooring Clusters (Starboard Side)
Table 1 UT Readings (inches) of Forward and Aft Clusters ("N" signifies the channel side of the monopile. "E", "S" and "W" signify measurements through the compass rose on 90 degree clockwise increments from "N" measurement)
